CCR SURFACE IMPOUNDMENT EMERGENCY ACTION PLAN

Plant Daniel Ash Pond B

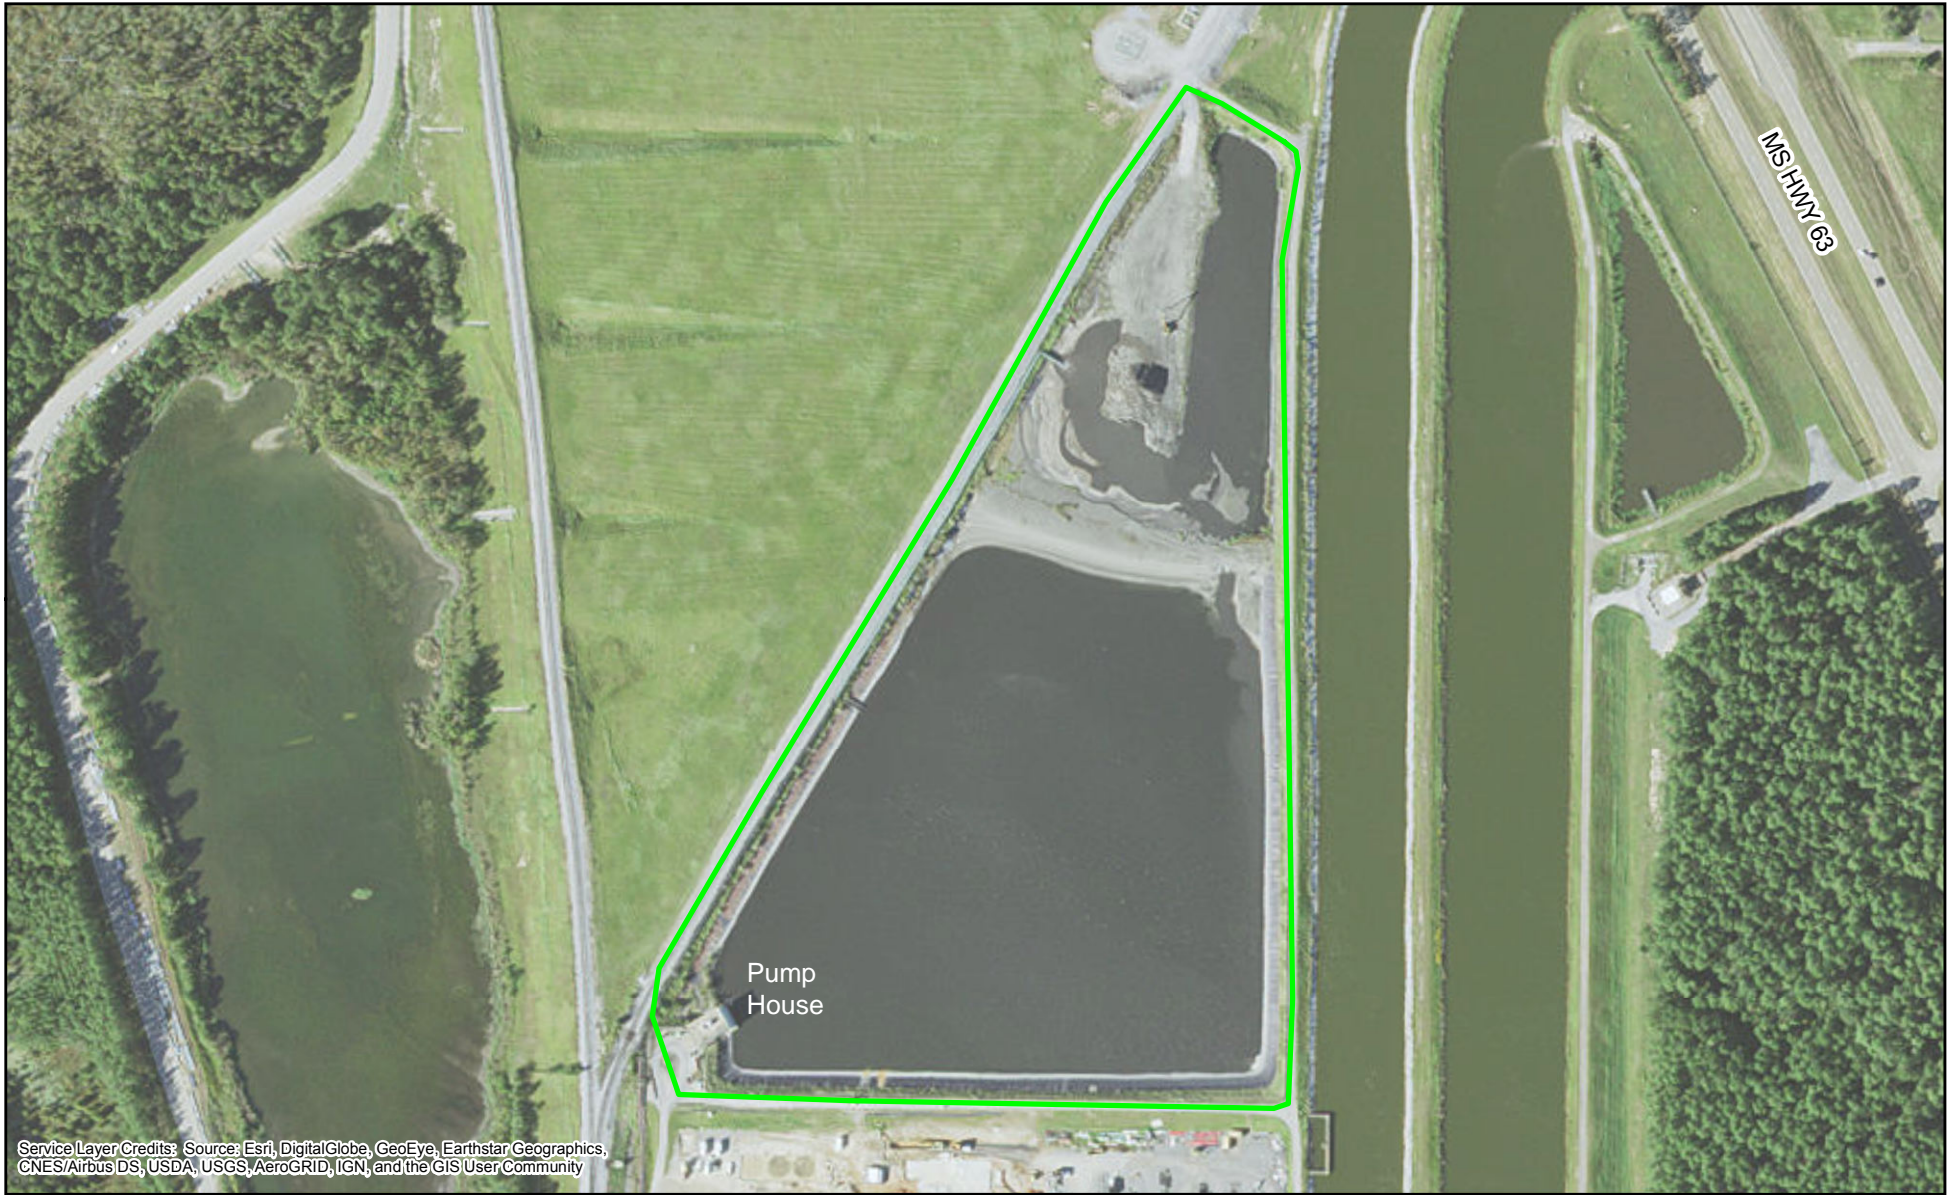
FIGURE 2
ASH POND B OVERVIEW
PLANT DANIEL
JACKSON COUNTY, MISSISSIPPI

Ash Pond B is approximately 23 acres in size and has a normal pool elevation of 23 feet or lower (Appendix A – Figure 2). A portion of these 23 acres is utilized for decanting sluiced bottom ash and contains little to no standing water. The Ash Pond has earthen embankments (also referred to as dam/dike) on its west, east, and south sides. The crest elevation of the perimeter dike is about EL 39 feet. The interior slopes are covered with 60-mil HDPE geomembrane. The crest surface is composed of grass and a gravel access drive. Downstream slopes are covered with grass and/or riprap.

Figures 1 and 2 in Appendix A illustrate the location of Ash Pond B within the Plant.

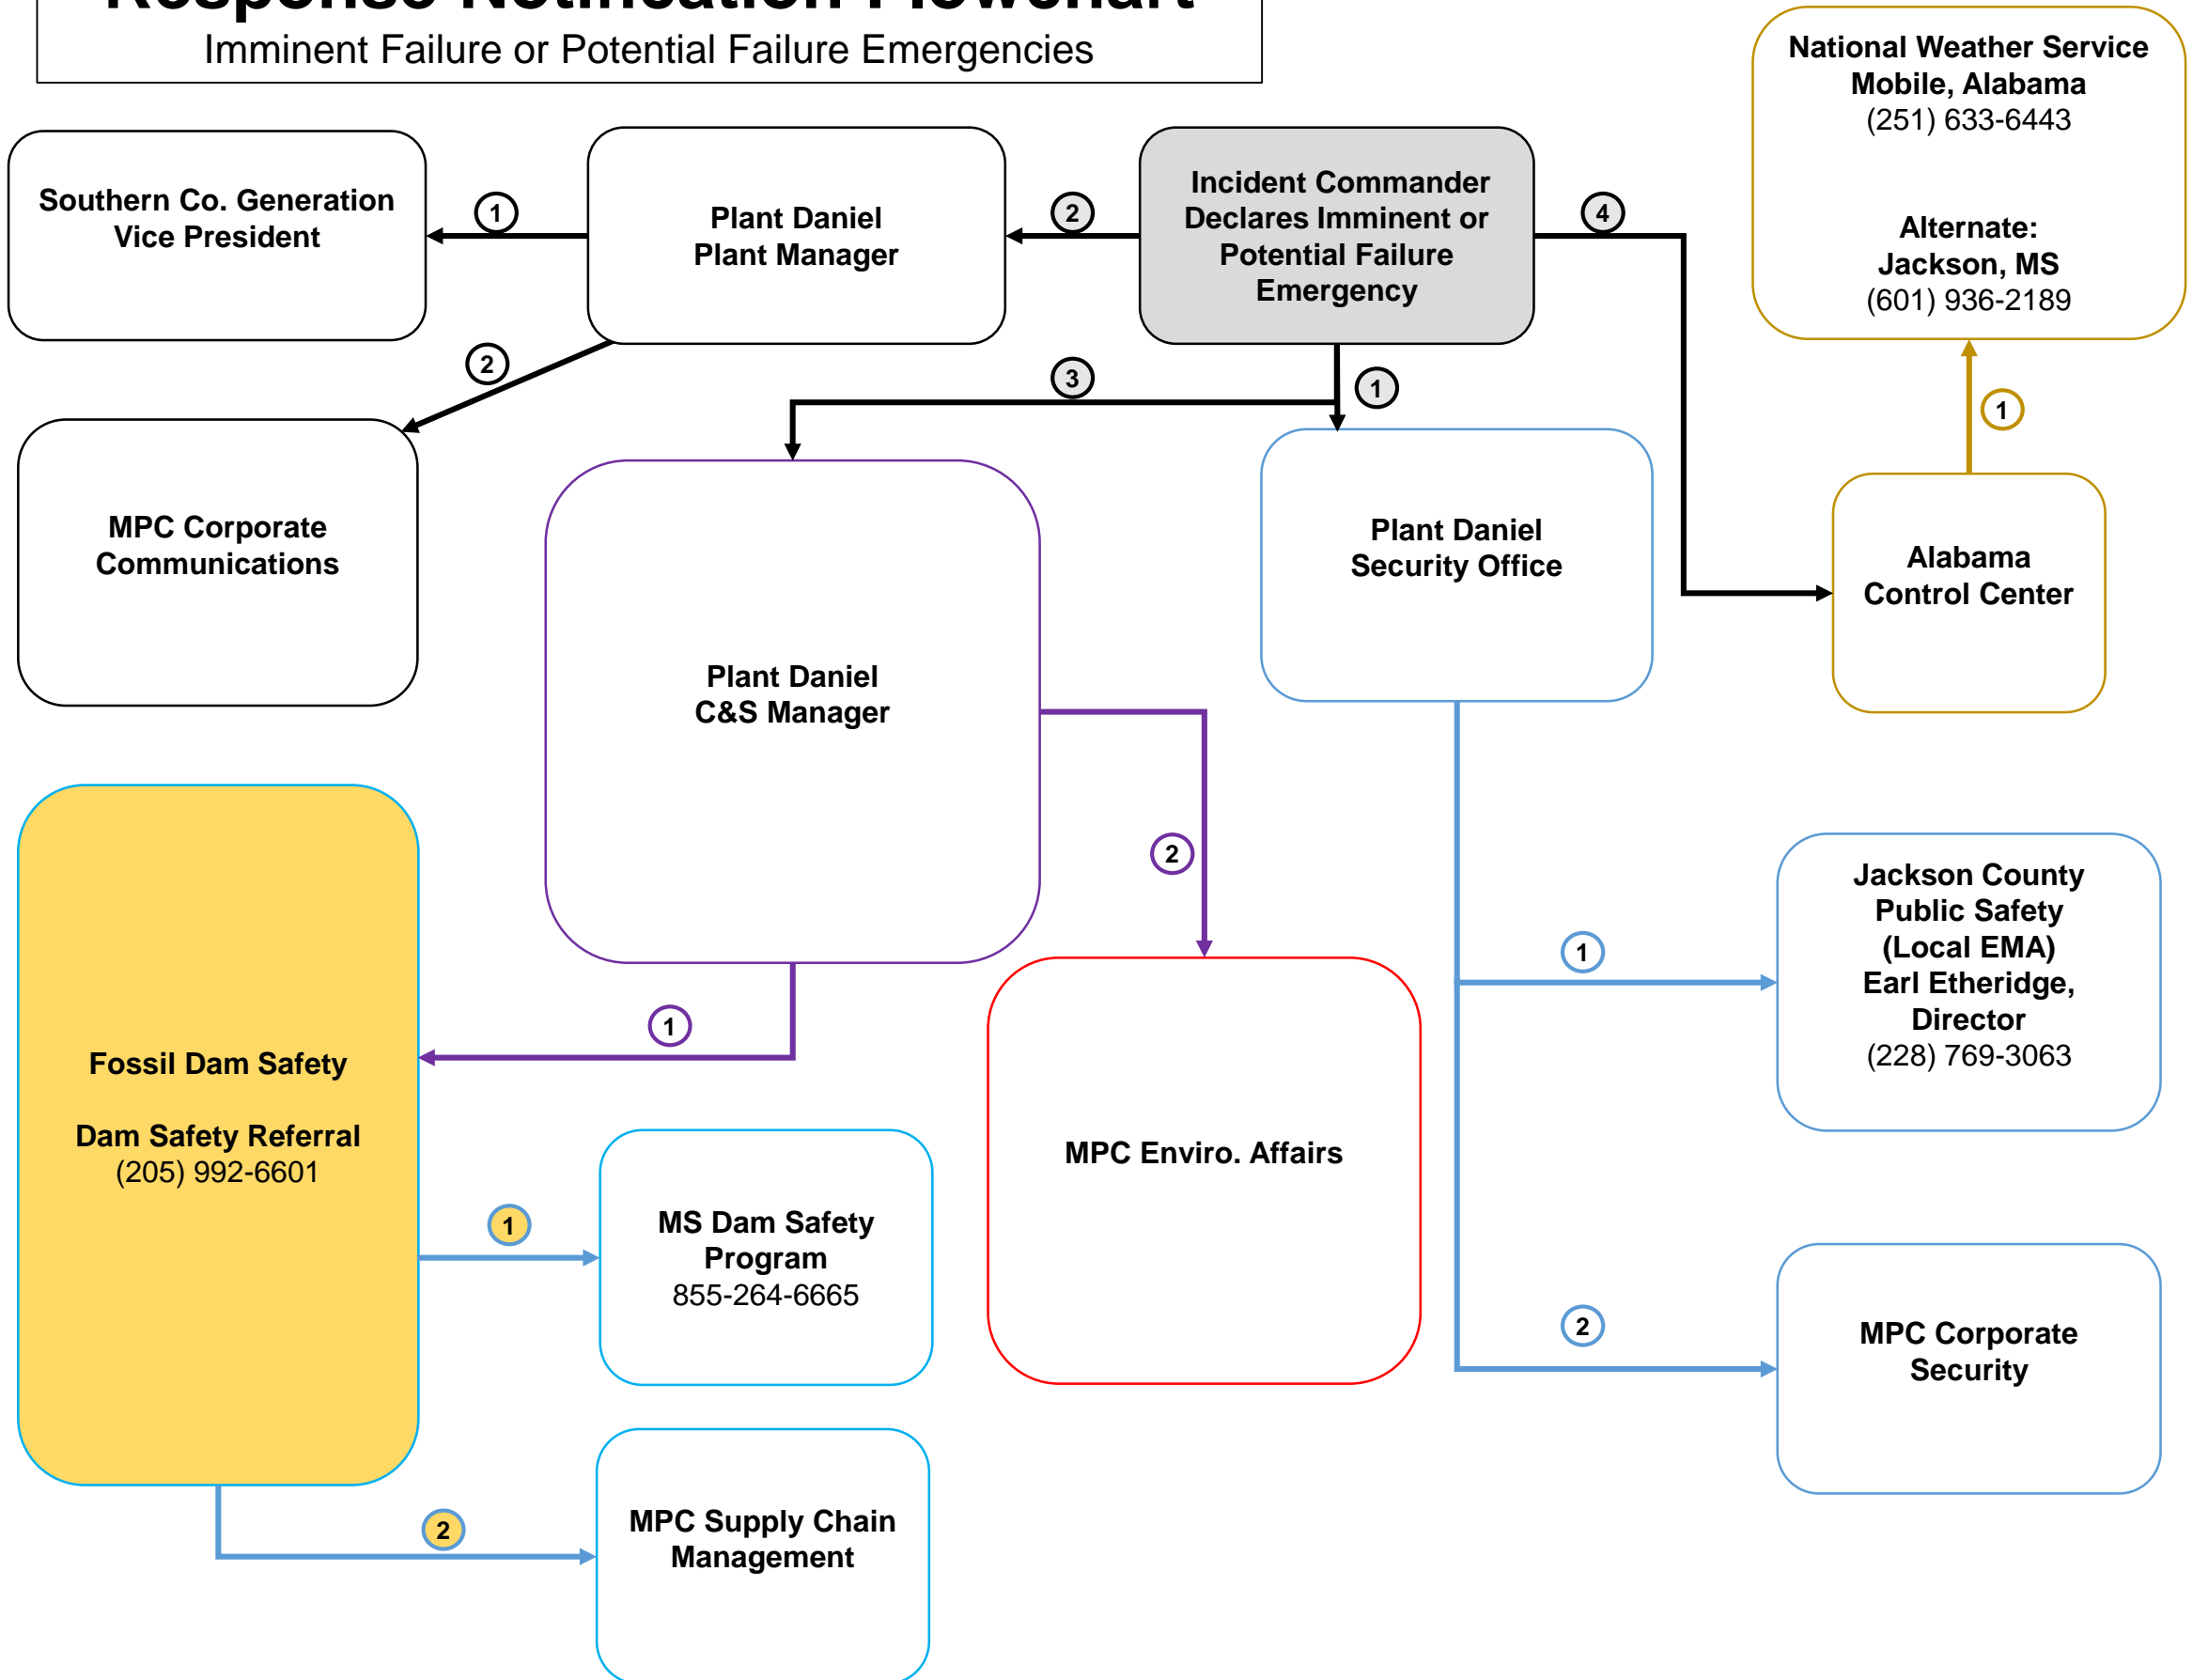
Response Notification Flowchart

Imminent Failure or Potential Failure Emergencies

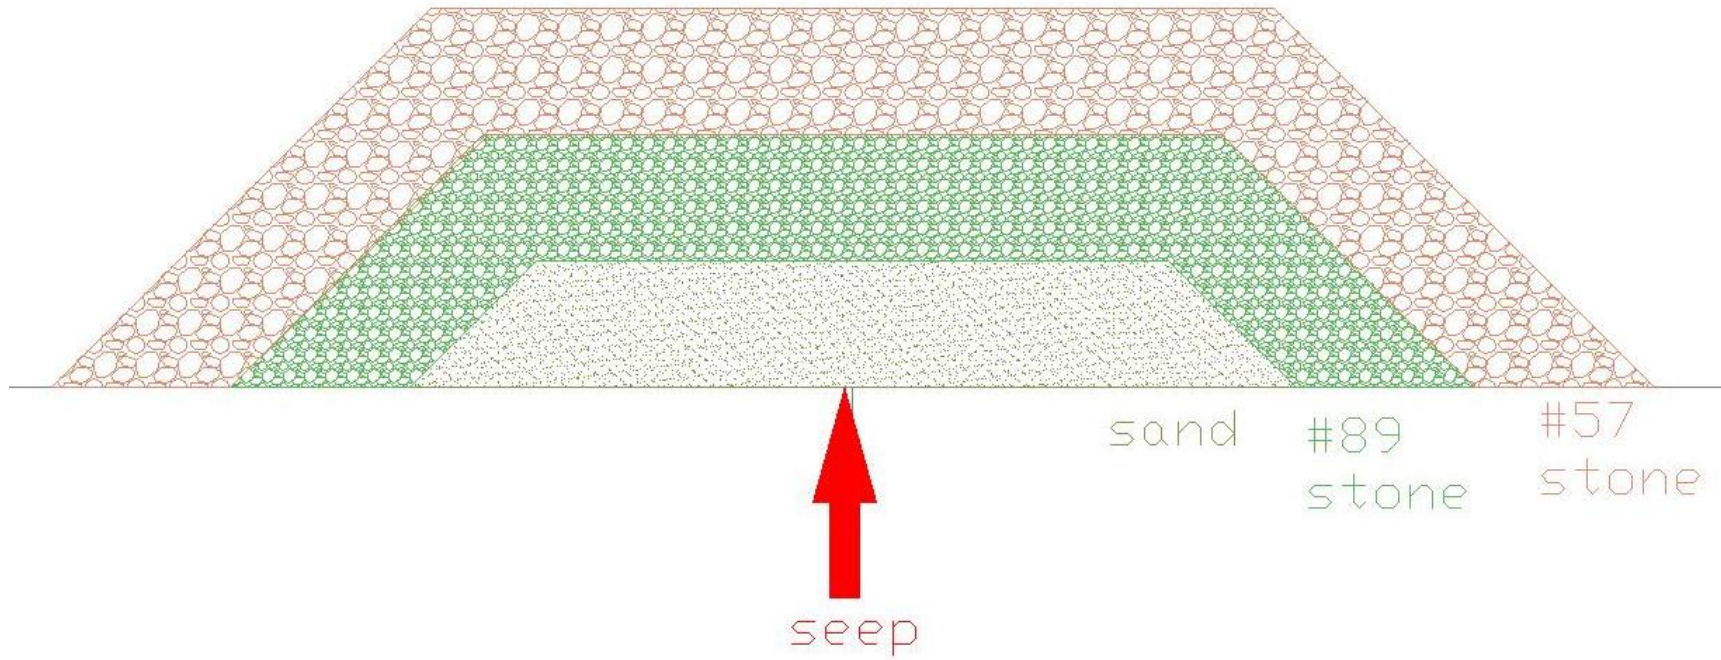
CROSS SECTION OF A REVERSE FILTER OVER A SEEP OR BOIL

Filter fabric or geotextile is not acceptable as a substitute for the sand. The fabric tends to smear and clog if applied in a wet situation.
